Window condition report, St. Andrew's Presbyterian, Victoria B.C.

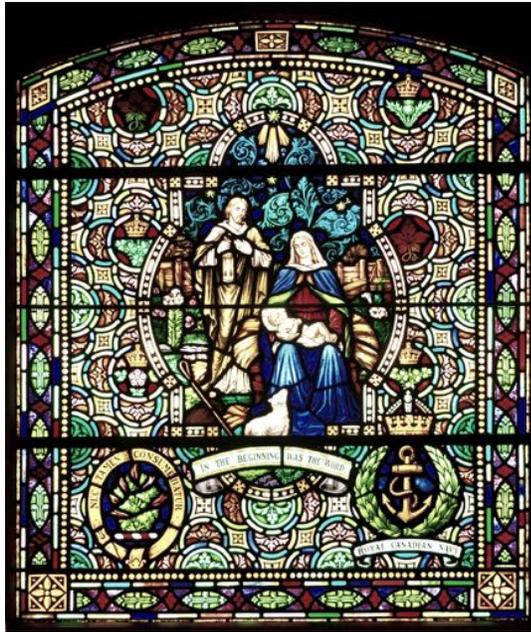
A- Royal Canadian Navy

A - Royal Canadian Navy, no studio or date, as with 'A' to 'H', 55" wide X 66" tall

Generally firm, tight in rebate, pronounced deflection in the top panel (too tight?)

Two T-bars and two saddle bars, wire ties, all good

Protective glazing (PG) Plexiglass in light aluminum frame, clipped in place, unvented

Rating: 3.5 - monitor, vent PG

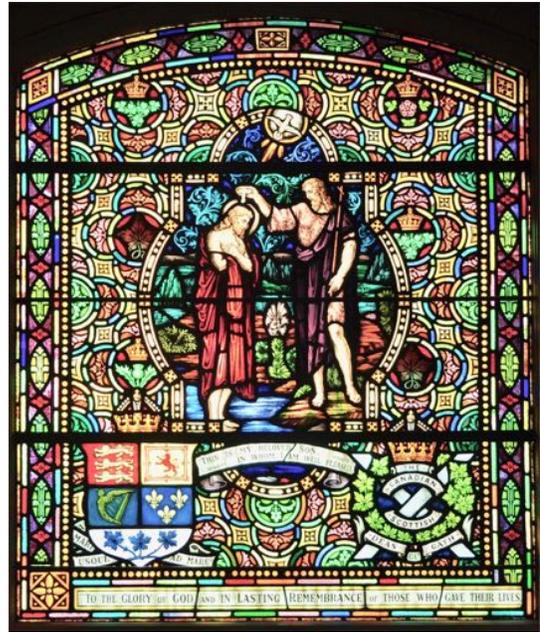
B - Canadian Scottish Regiment, 55" X 66"

Firm, flat, tight, steel bars and ties as in 'A', all in good shape

PG as in 'A', unvented

Rating: 4.5 - monitor, vent PG

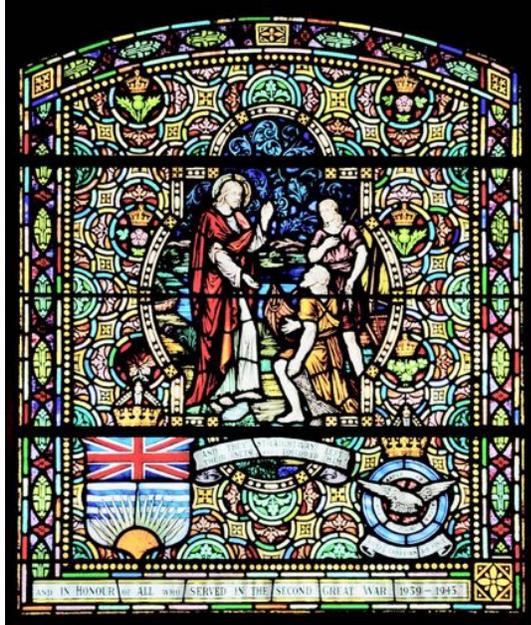
C - Royal Canadian Airforce

C - Royal Canadian Airforce, 55" X 66"

Generally firm, slight deflection at top, pronounced at bottom, Union Jack glass cracked

Steel bars, ties as in 'A', all in good shape

PG as in 'A', unvented

Rating: 3.0 - monitor, vent PG

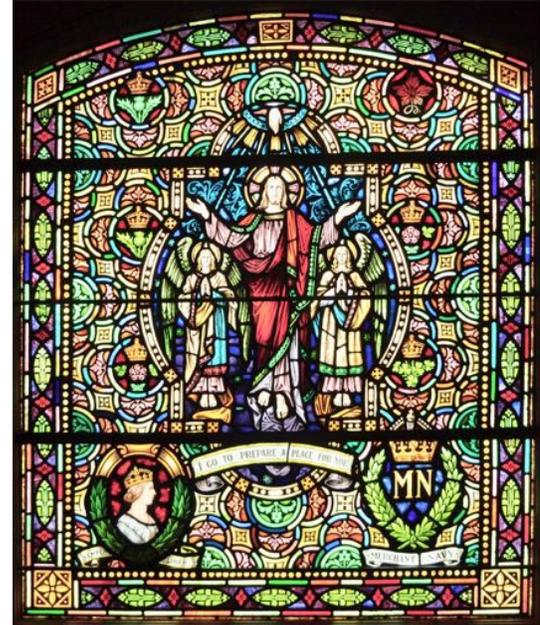
D - Merchant Marine

D - Merchant Navy, 55" X 66"

Firm, flat, tight, steel bars and ties as in 'A', all in good shape

PG as in 'A', unvented

Rating: 4.5 - monitor, vent PG

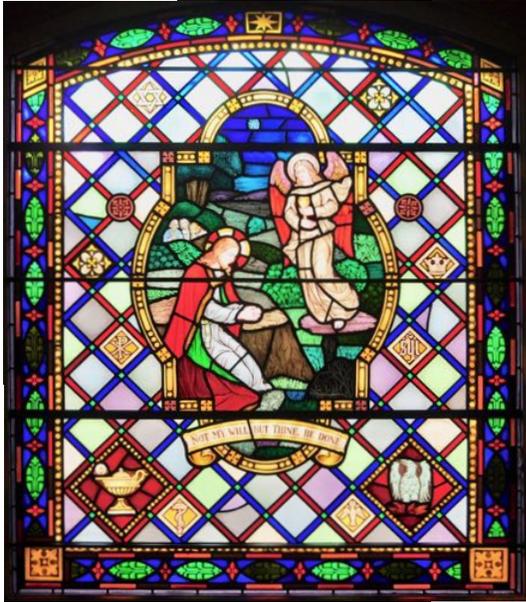
E - "Not My Will..."

Flat, firm, tight, one minor crack in filet (border)

Two T-bars, three saddle bars, ties somewhat loose

PG in light aluminum frame installed in separate wooden sash with clips (some clips not securing aluminum frames properly), small cracks at bottom of Plexiglass, not vented

Rating: 4.5 - monitor, vent PG, consider adding more venting to these four windows

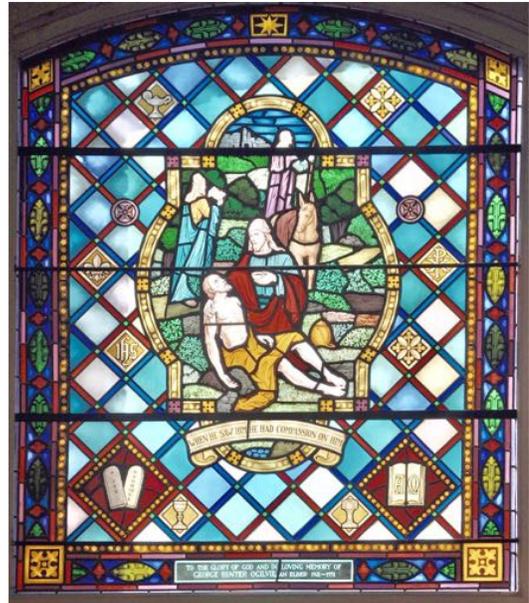
F - Ogilvie

F - Ogilvie, 55" X 66"

Flat, firm, tight, cracks in purple robe, other minor cracks

Steel bars, ties as in 'A', all in good shape

PG as in 'E', but vented

Rating: 4.5 - monitor

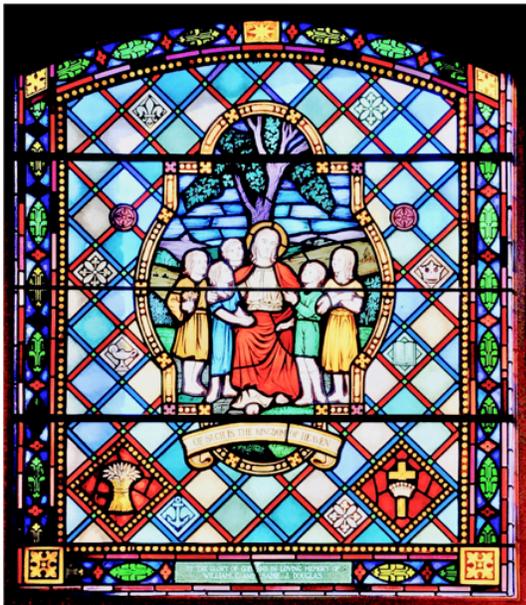
G - Douglas

G - Douglas, 55" X 66"

Flat, firm, tight, steel bars and ties as in 'A', all in good shape

PG as in 'E', vented

Rating: 4.5 - monitor

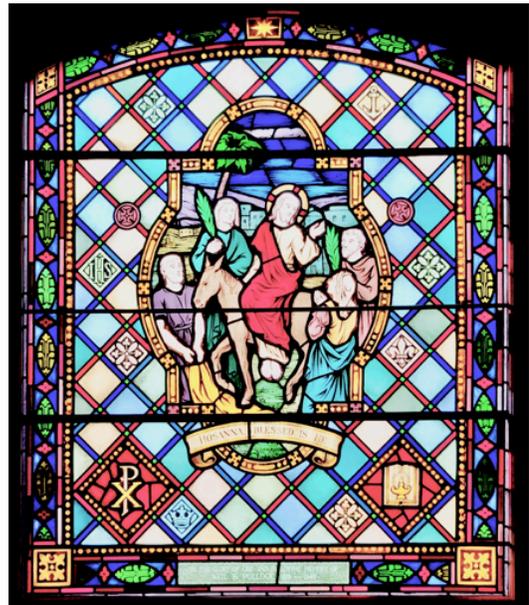
H - Pollock

H - Pollock, 55" X 66"

Flat, firm, tight, steel bars and ties as in 'A', all in good shape

PG as in 'E', small cracks at bottom of Plexiglass, vented

Rating: 4.5 - monitor

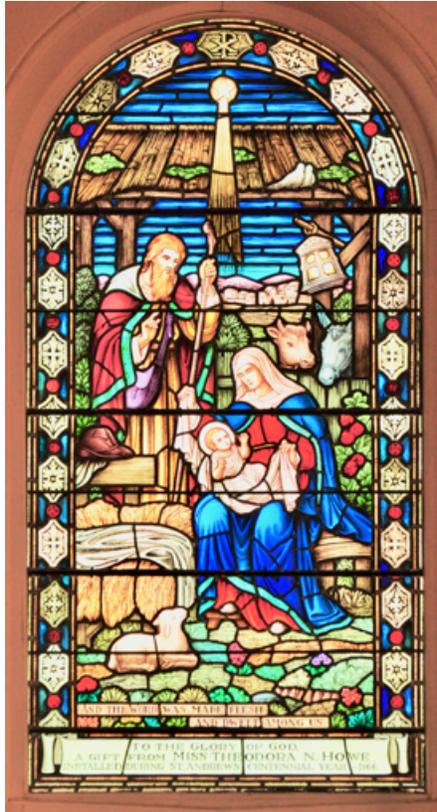
I - Howe

I - Howe, McCausland Studio, Toronto, 1966, 59" X 115"

Fairly firm, flat except pronounced deflection at bottom, tight

Four T-bars with metal tabs holding the window, no caulking or putty on T's

Four 1/2" saddle bars, several copper ties not done up (rectified)

PG in separate light aluminum frame held in place with clips, not vented

Rating: 3.5 - monitor, vent PG

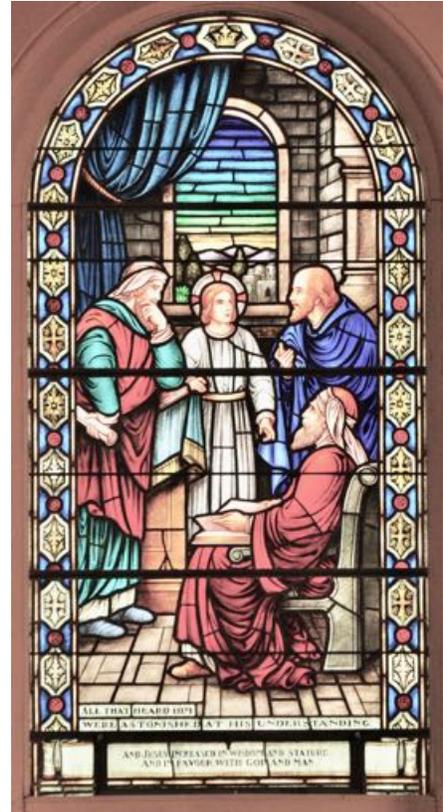
J - "All that Heard.."

J - "all That Heard Him..." (dedicated to many) , 59' X 115"

No studio or date noted, probably McCausland Studio

Fairly firm and flat except pronounced deflection at top, tight

Four T-bars with putty, four saddle bars reduced to 3/8", ties good

Steel opening panel (ventilator) at bottom

PG as in 'I', unvented

Rating: 3.5 - monitor, vent PG

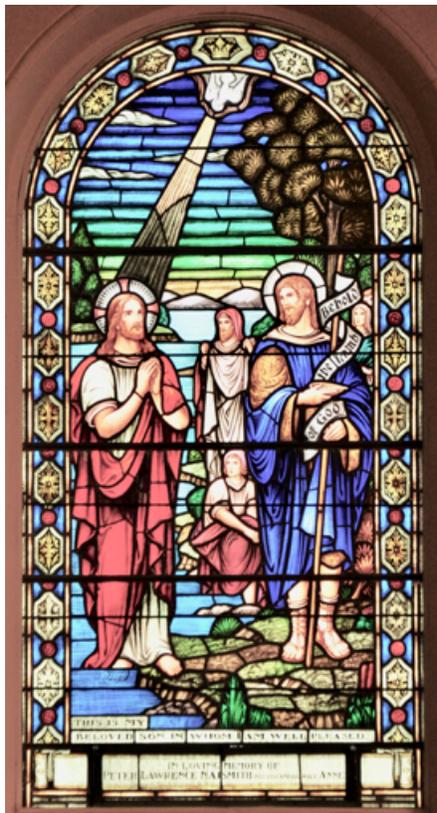
K - Naismith

K - Naismith, no date/studio, probably McCausland Studio, 59" X 115"

Fairly firm, moderate deflection throughout, more pronounced at top, tight

T-bars, bars, ties and opener as in 'J', good

Rating: 3.5 - monitor, vent PG

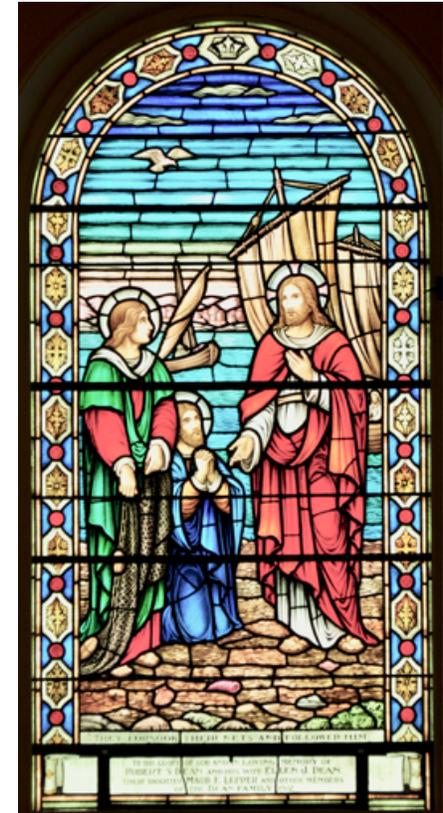
L - Dean et al, McCausland Studio, 1972, 59" X 115"

Fairly firm, flat, except pronounced deflection at top, tight

T-bars, bars (now 1/2"), ties and opener as in 'J', good

Rating: 3.5 - monitor, vent PG

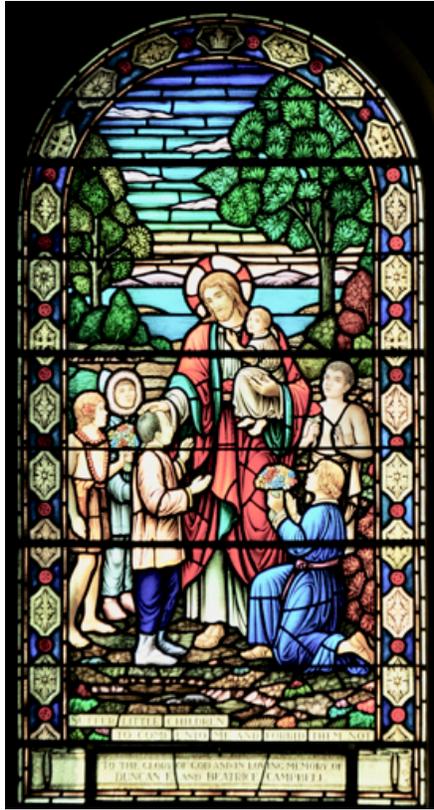
M - Campbell

Fairly firm, tight, moderate to pronounced deflection throughout, but severe at bottom

Four T-bars with tabs, no putty/caulking at T's, four 1/2" saddle bars (top bar not affixed to sash), ties good, steel opener at bottom

Pg in light aluminum frame, held with clips, unvented

Rating: 2.5 - monitor, vent PG, affix loose saddle bar, plan to address lower panels

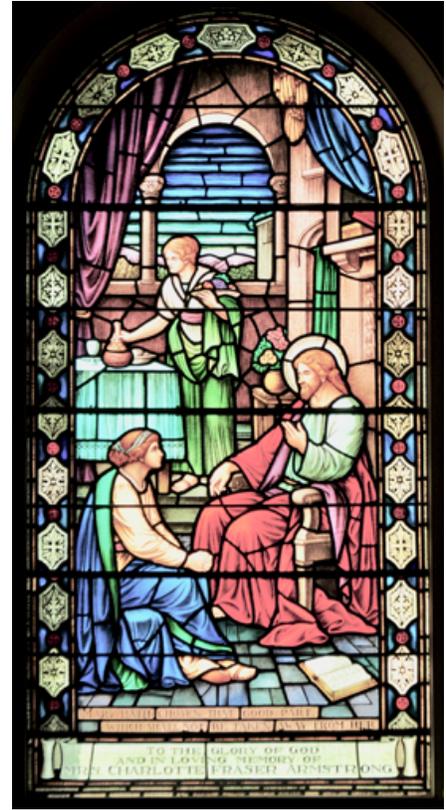
N - Armstrong

N - Armstrong, McCausland Studio, 1966, 59" X 115"

Fairly firm, tight, minor to moderate deflection throughout, except severe at bottom

Four T-bars with caulking, bars/ties good

PG as above

Rating: 3.0 - monitor, vent PG

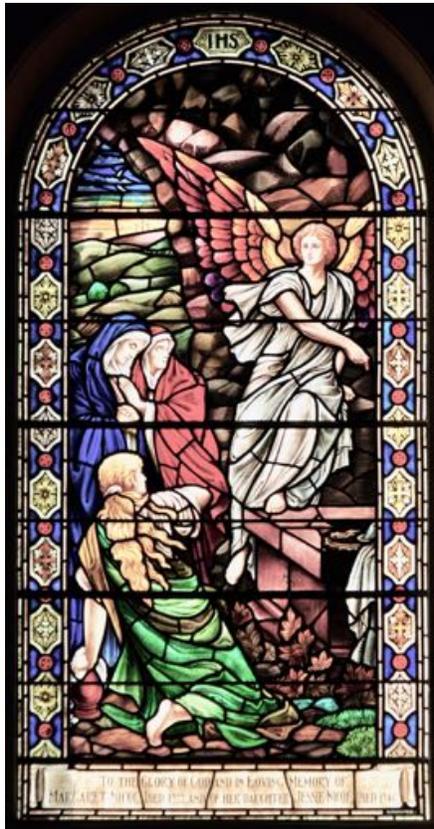
O - Nicol

O - Nicol, McCausland Studio, 1946, 59" X 115"

Fairly firm, moderate overall deflection

Four T-bars, puttied, bars and ties as above, good

Some evidence of prior leakage, probably before PG installed

PG as above

Rating: 3.0 - monitor, vent PG

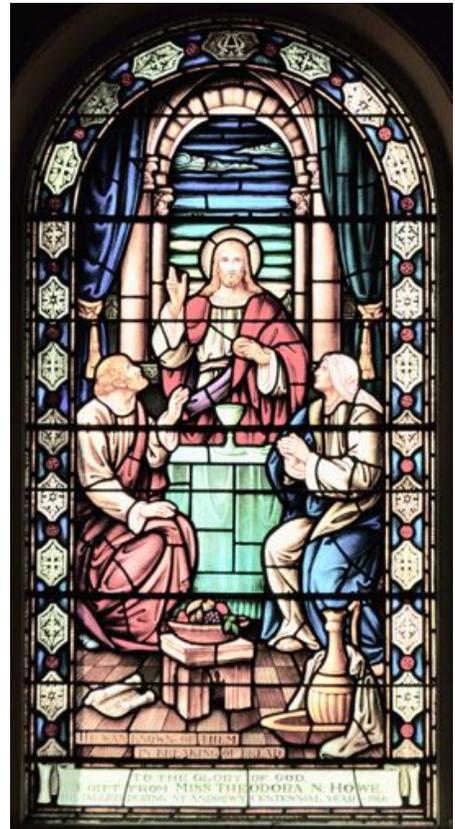
P - Howe

P - Howe, McCausland Studio, 1966, 59" X 115"

Fairly firm, flat, except severe deflection at bottom, chalice cracked, rest OK

T-bars caulked, otherwise bars/ties as above, good

Leakage noted as above

PG light aluminum frame missing, Plexiglass is severely bowed in (against stained glass) and out, loose, not secure

Rating: 3.5 - except 2.0 at bottom - monitor, plan to address lower panel and PG issues (including venting when properly installed)

One window does need to be remedied, the PG on the Howe window ('P') has come out of it's aluminum frame (some of the frame appears to be missing), is barely supported, and is bowing against the stained glass. Being a balcony window access is not simple. If a lift is provided to address this PG it would be prudent to vent all of the balcony windows on that side. Cost is difficult to arrive at until it is determined why this PG has failed so completely.

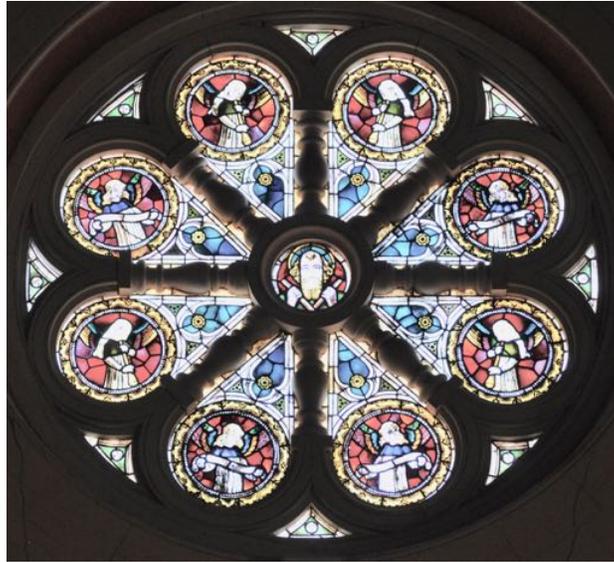
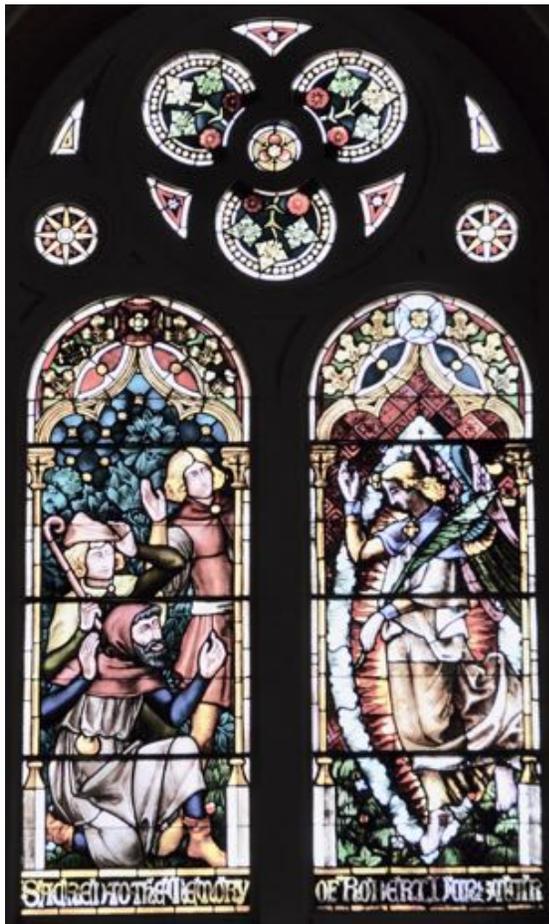
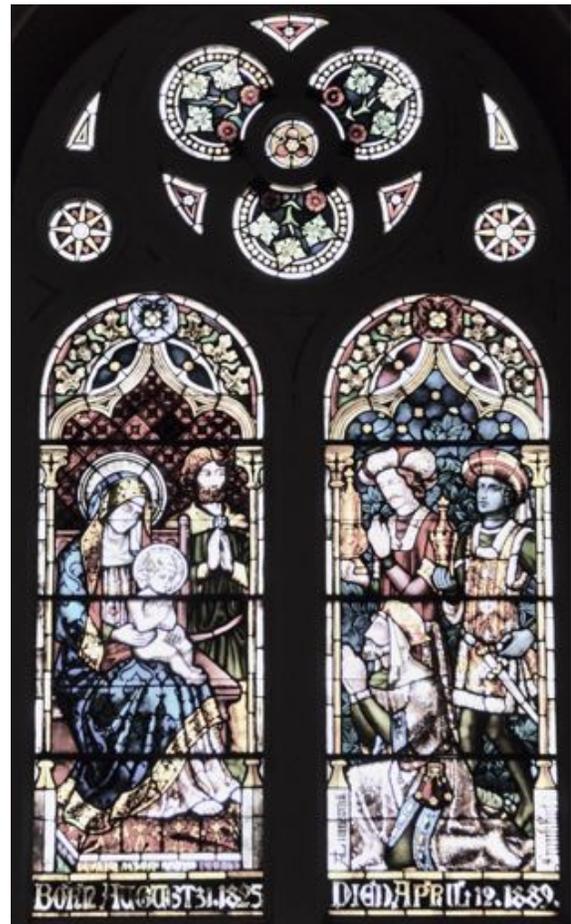
Q- Dunsmuir (4) and R - Rose and Tracery

Q - Dunsmuir, by A. Linneman, Frankfurt, 1889, two pairs, each window 33" X 94"

Generally fair, reasonably firm, flat, (previously rebuilt), with exceptions noted.

Three T-bars each, some silicone caulking, scant room on T-bars to interior to hold window, no method of attaching windows to T-bars (top right panel actually bowed inward past edge of T-bar, showing daylight)

Were four light flat bars originally per window, two are now missing, three are partly detached, soldered on one side only as improper attachment to panels

Paint condition is compromised and fragile, some missing, probably due to borax flux sometimes used in late 19th century, found to be deficient

PG - installed in rebate with stained glass pressed tight against it, (hence scant room to interior on T-bars), unvented, no effective air movement even if vented, evidence of trapped condensation between stained glass and PG

Rating: 1.5 - Top right panel, remove, flatten/relead, add missing bar, install with effective attachment to T-bar

2.0 - Installation, all windows - address T-bars and lack of attachment

3.0 - General condition - though all should be removed, missing bars and T-bar issue addressed, and reinstalled without PG

1.5 - PG - Four Dunsmuir windows should be removed and reinstalled with a different method of providing properly vented and spaced PG (or no PG)

R - Rose Window and Tracery, no studio or date noted, perhaps not by A. Linneman

as the paint style and finish seems by a different hand or studio, paint seems stable

Firm, flat, (previously rebuilt), tight, no bars (inadequate)

PG as above

Rating: 3.5 - monitor, remove, add bars and reinstall without PG

These are difficult to estimate without some hands-on experience with their installation and condition. The one top-right panel of the four has severe bowing and is partially off the T-bar supporting it, rated at 1.5 (very poor).

Cost: \$2500 - 4000.00 - remove, flatten, add bar, install against existing PG

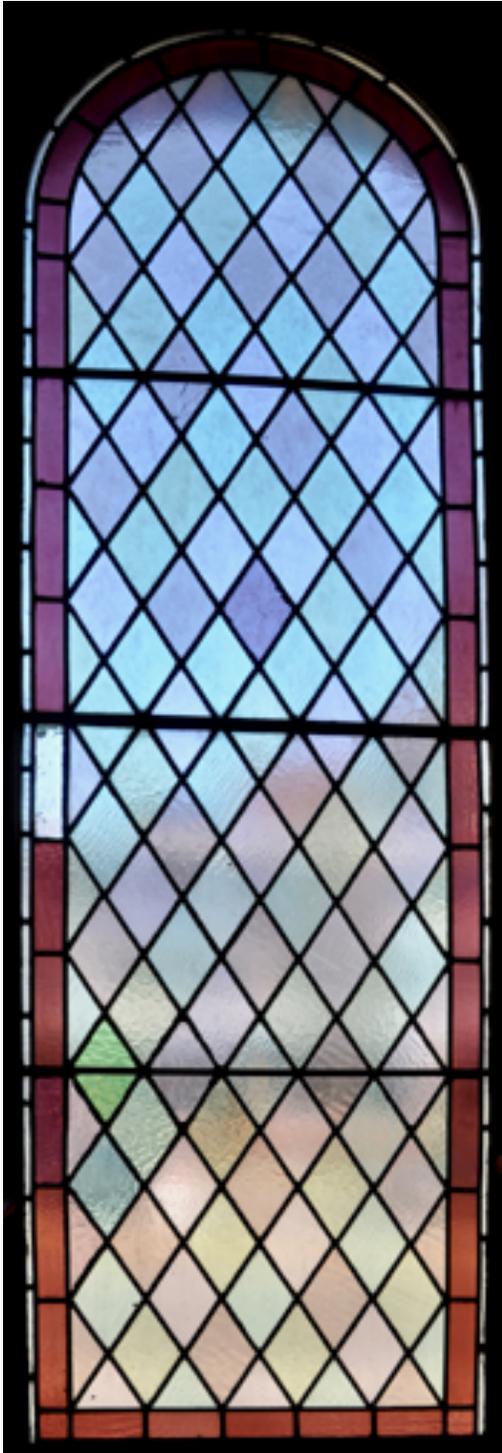
S - South-East Stairwell (3)

S - South-East Stairwell, no studio/date (leaded glass, original to the church),

Three windows, 24" X 78"

Upper and Lower staircase - Fairly firm and flat, lead and attendant cement in comes

showing age, not due for restoration yet, one lap joint, three 3/8" square bars, ties good

Middle staircase - Previously restored by Mercer & Schaefer Glasstudio, Victoria, B.C.

No PG on these windows

Rating: 3.0 - Upper and lower windows, monitor

4.5 - Central staircase, no intervention

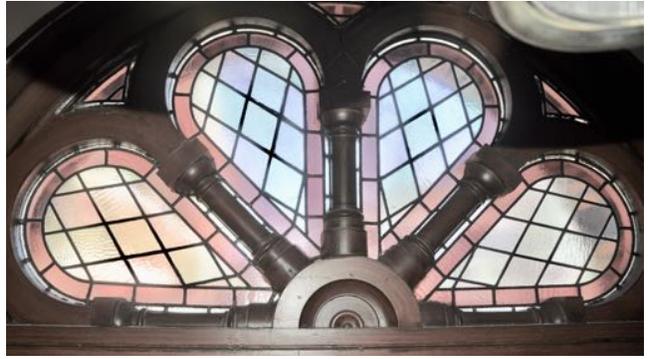
T - East, Douglas St. Entry (4)

T - East, Douglas St. Entry, original leaded glass

Four leaded windows over doors, each with seven panels, and four narrow zinc-lights in the doors

Somewhat firm, showing their age, numerous cracks and previous repairs, to repair is to commit to restoration, (one panel protruding inward, broken lead, glass edge showing)

Zinc lights, good condition

No bars, no PG, none required

Rating: 2.0 - one panel - restore

3.0 - remainder - monitor

4.0 - Zinc lights - no intervention

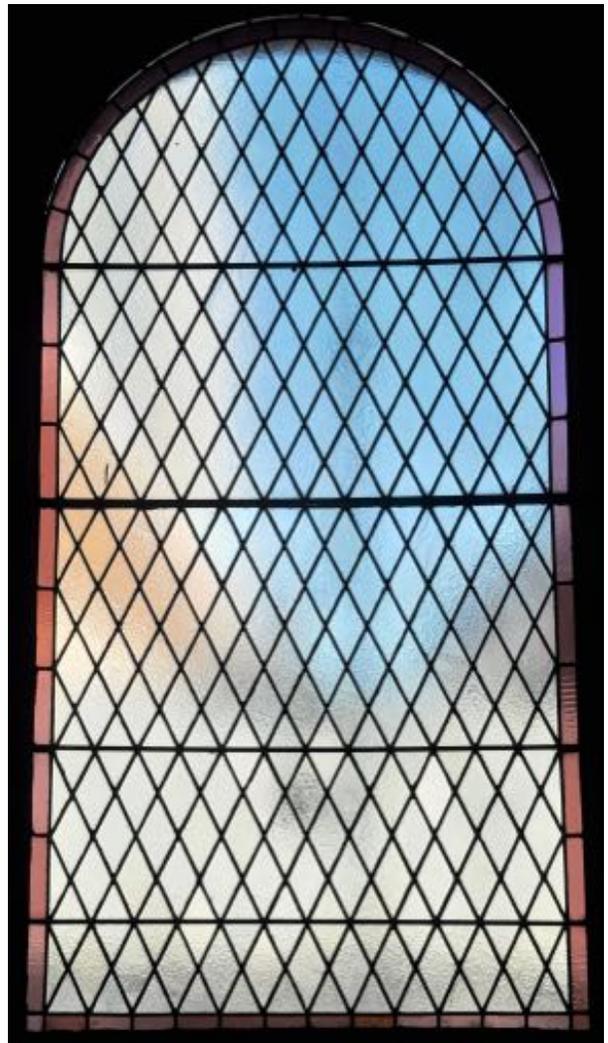
U - N/E Tower, Lower Stairwell, East Window

U - Lower stairwell, East Window, 44" X 82"

Soft, loose, previous repairs, buckling at bottom

Four 3/8" bars, one lap joint (pulling apart at lap, showing daylight), many broken ties

Lead aged, cement crumbling

No PG

Rating: 2.0 - needs restoration

Cost: \$7350.00 - fully restore as above

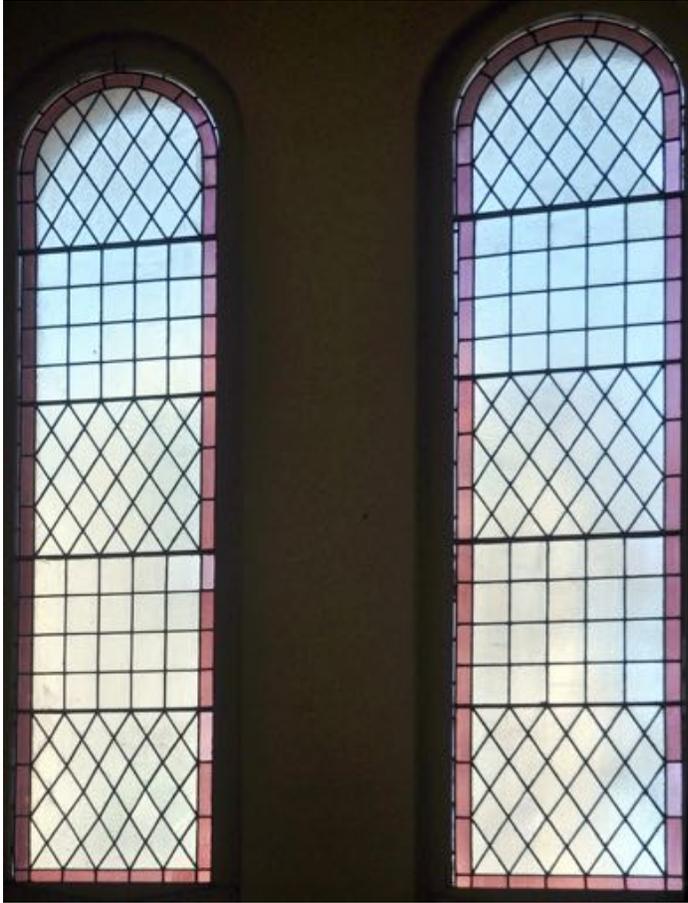
V, W - N/E Tower, Middle Stairwell,
East & North Pairs

V - Middle Stairwell, East Pair, each 24" X 103"

Soft, loose, previous repairs, bowing

Four square 3/8" bars, some loose ties, two lap joints

Lead is worn, cement crumbling, loose

No PG

Rating: 2.0 - needs restoration

W - Middle Stairwell, North Pair, each 24" X 103"

Similar to 'V' beside them, but less sun (North exposure) tends to reduce expansion/contraction and stress on windows

Rating: 3.0 - monitor

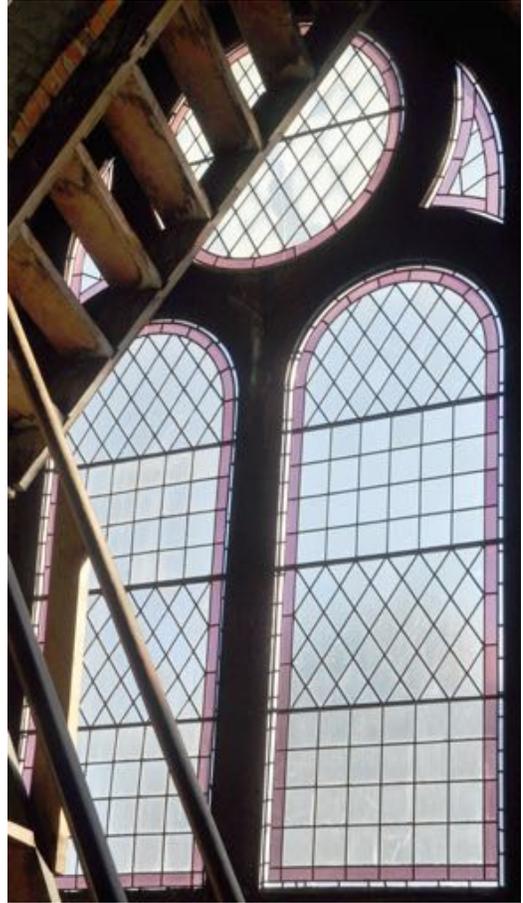
X - Upper Stairwell, East

X - Upper Stairwell, East, pair, each 28" X 75", round 38" dia., two small tracery

Right of pair restored previously by Mercer & Schaefer, one lap joint, three bars

Left of pair - weak, loose, cracked glass, deflection, lead is worn, cement crumbling

No PG on pair

Round - soft, loose, weak, very poor condition, broken glass, numerous broken solder joints, all ties broken off the one bar

PG is cracked in two

Rating: 4.5 - Right panel of pair, no intervention

2.0 - Left panel, restore

1.0 - Round window, danger of collapse, restore

2.0 - Tracery, restore

Cost: \$2900.00 - as above, with little or no woodwork expected, remove PG

Cost: \$5350.00 - as above, full restoration of windows

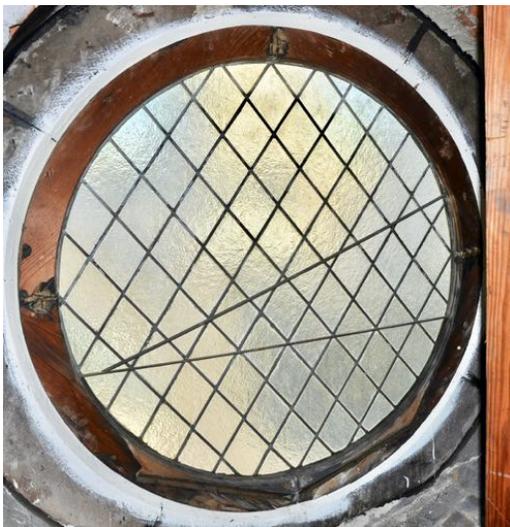
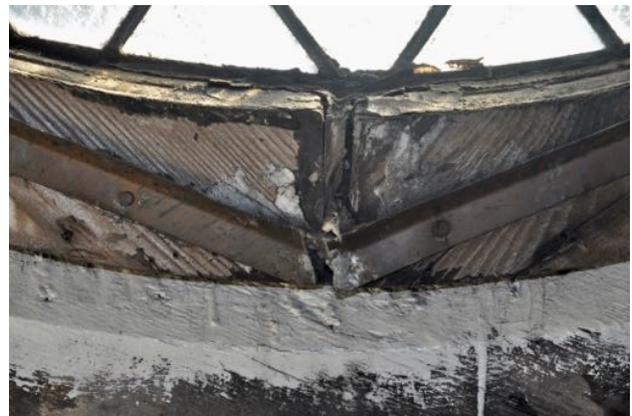
Y - Clock Tower (4) and Sash Detail

Y - Clock Tower, four round, each 41" dia.

Very soft ('floppy'), loose, weak, very poor condition

Two thin flat bars soldered to each, many solders on bars broken (one fallen off)

No PG

Sash in need of attention as well

Rating: 1.0 - danger of collapse, restore, and attend to sash

Cost: \$12500.00 - remove, cover the openings, restore the windows, and install in existing sash. The sash need attention as well, with costs determined once they are removed.

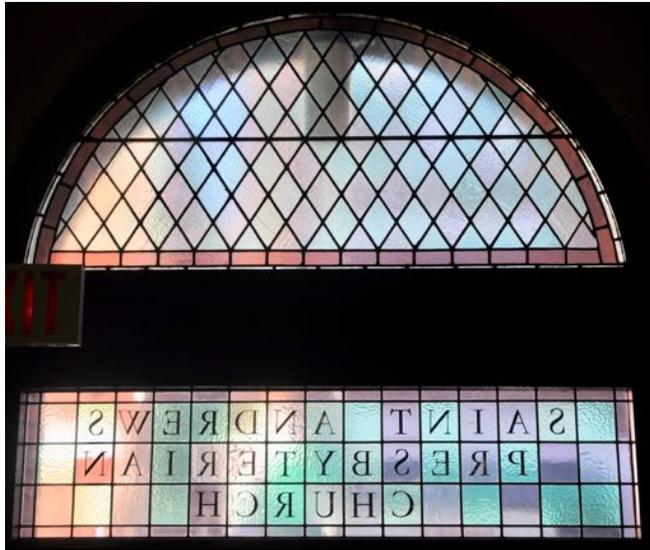
Z - North (Broughton) Entry

Z - North (Broughton) Entry, office and studio entrance, original leaded, 63" X 15"

Lower over door -Firm, flat, loose in sash

No bars (deficient)

Upper arched over door - fairly firm, slight deflection, lead OK

One bar, ties good

PG unvented

Rating: 4.0 - Lower window over door, monitor, vent PG

3.5 - Upper arched over door, monitor, vent PG

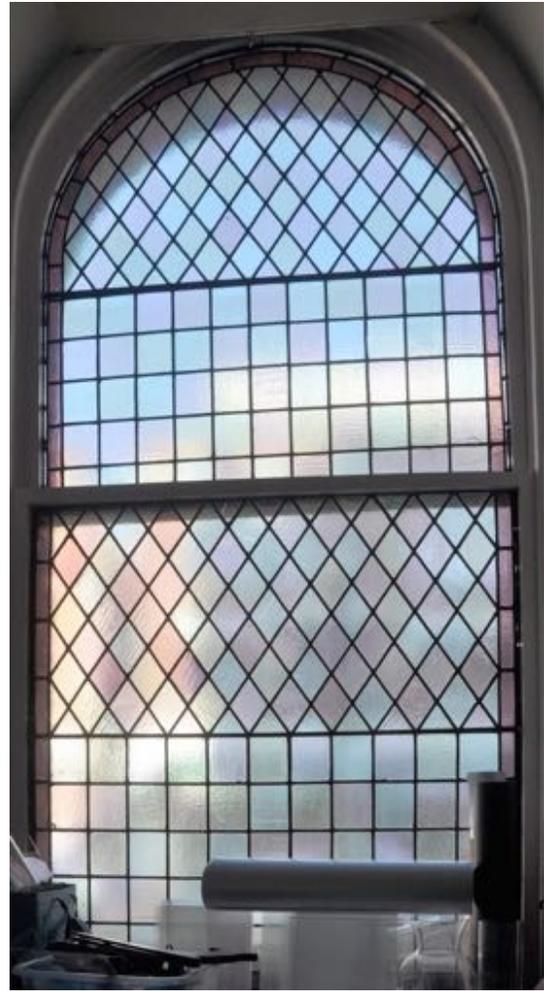
AA, BB - East and West of Broughton Entry (2)

AA - Small Room East of Entry, original leaded, 47" X 98"

Single hung sash, not operable

Somewhat firm, slight deflection, two bars only (deficient), cement deteriorated,

PG unvented

Rating: 3.0 - monitor, vent PG

BB - West of Entry, handicapped washroom, as above 'AA'

Similar to above, except smaller bars added later, ties compromised

Rating: 2.5 - monitor, vent PG

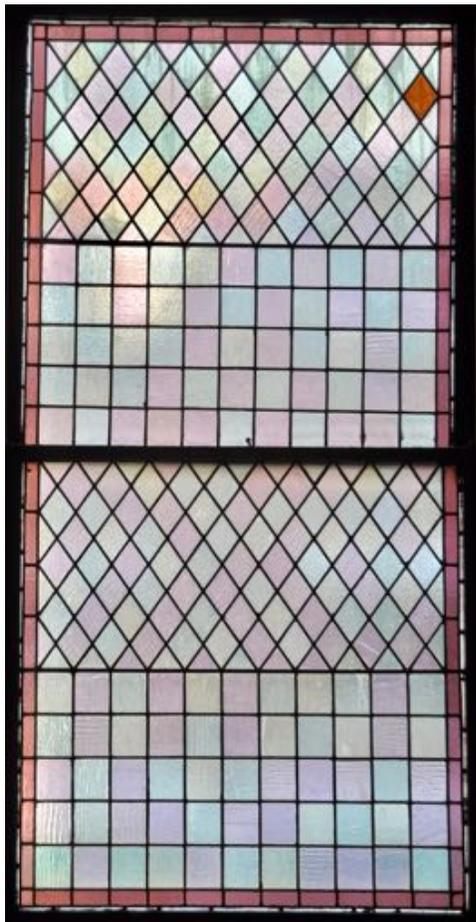
CC, DD - North Stairwell and Office (3)

CC - North Stairwell to Offices, original leaded, 47" X 95"

Single/double hung sash, not operable

Not very firm, numerous previous repairs, lead and cement worn out

Two bars only (deficient), some ties broken

No PG

Rating: 3.0 - monitor

DD - Upper (North) Office, Two, as per "CC"

More extensive deflection, broken leads, cracked solders, one appears to be upside-down compared to the other two similar windows

Rating: 2.5 - monitor, plan for restoration
