Window condition report, St. Andrew's Presbyterian, Victoria B.C.

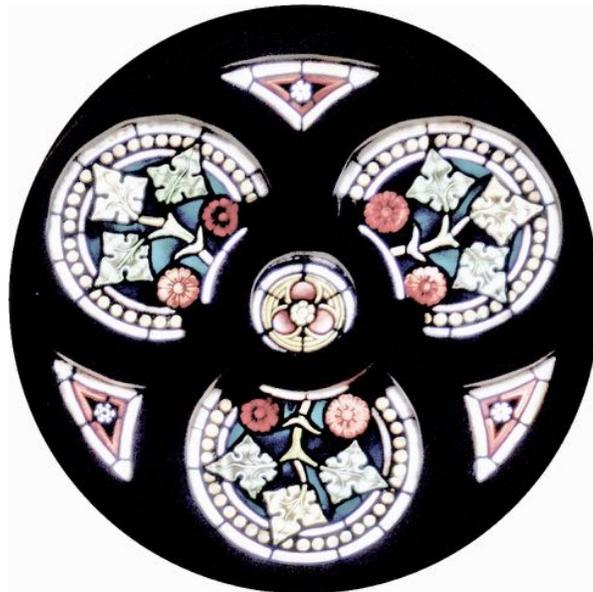
A- Royal Canadian Navy

A - Royal Canadian Navy, no studio or date, as with 'A' to 'H', 55" wide X 66" tall

Generally firm, tight in rebate, pronounced deflection in the top panel (too tight?)

Two T-bars and two saddle bars, wire ties, all good

Protective glazing (PG) Plexiglass in light aluminum frame, clipped in place, unvented

Rating: 3.5 - monitor, vent PG
